Summary Inspection Report of FIRE ESCAPES AND FIRE ESCAPE BALCONIES

Re: Bromley House
6901 Old York Road, Philadelphia, PA 19126
Structural Engineering Services - Fire escape inspection

The inspection status of the fire escape balconies is "SAFE WITH REPAIRS & MAINTENANCE".

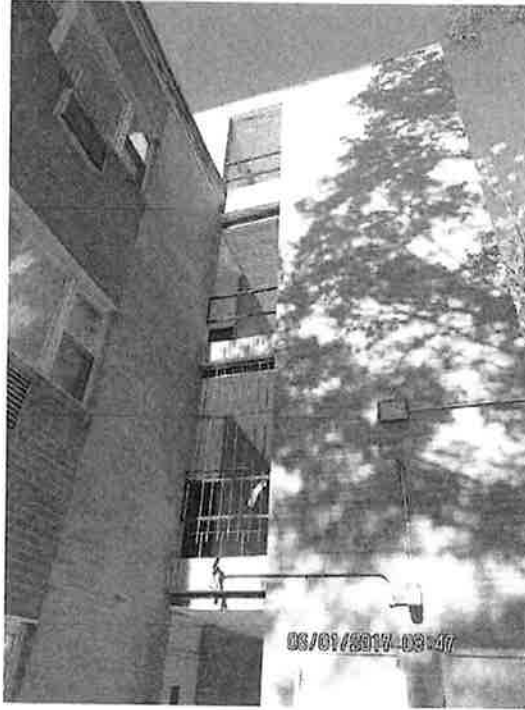
Typical Fire Balconies

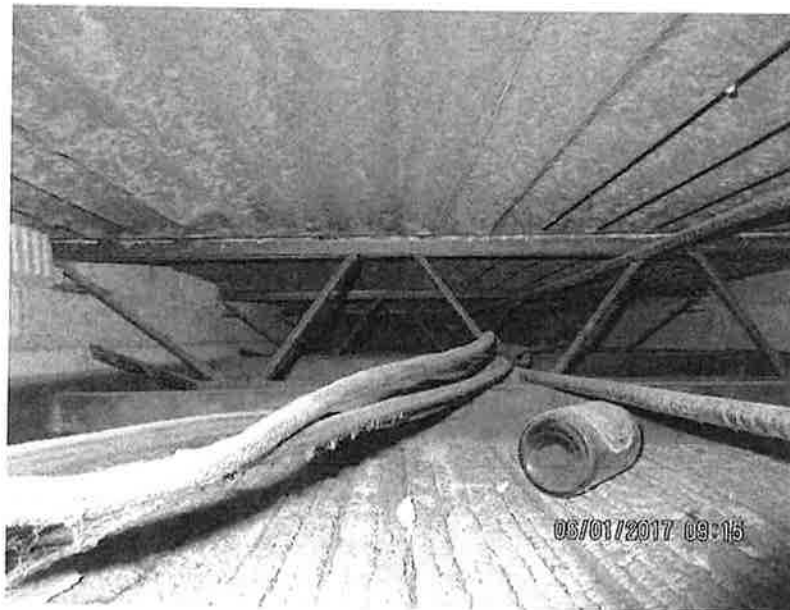
The fire escape balconies at the floor levels consist of 4" cast in place concrete slab on metal deck supported on 8" steel bar joist. Each balcony was covered with vinyl soffits which made it difficult to observe the entire underside of the balcony. At building A, the metal deck and bar joist were intact with surface rust. However, at building B the existing joist were intact but the metal deck was completely rusted away and missing, this will require the removal and replacement of the 4" concrete slab on new 9/16" corrugated galvanized metal deck. Due to field conditions at buildings C and D, the underside of the balconies were covered with plaster soffits making it impossible to observe the underside of the balconies, the extent of the rusting could not be determined. We are assuming that the framing is similar as in buildings A & B, and we recommend that the soffits be opened to verify the framing as well as the extent of the rusted damage. We expect the repair work would be similar. The fire balconies at the roof appear to have been previously replaced with 2x12 wood framing with a plywood deck. These balconies are suffering from water damage and are in poor condition. The wood framing and plywood will need to be replaced in kind with weather resistant wood treated materials and a waterproofing membrane. Our analysis of the fire escape balcony verifies that the existing in place steel bar joist framing can support the code applied loads with repairs to the concrete decking and the wood framing.

Building A – Surface Rust

1. Continue the general maintenance program of cleaning, wire brushing and painting of the rusted exposed steel framing of the fire balconies to prevent any further deterioration. Removal of the soffit framing is required for access to the painting of the underside of the steel framing & deck. Notify engineer of any members that have excessive rusting or delamination for further review or replacement.
2. Continue the general maintenance program of cleaning and sealing the fire balconies to prevent any deterioration. All minor surface spalls located on top of the concrete must be addressed. We recommend the spalls in the existing concrete slabs are to be repaired using Sika Armatec 110 EpoCem bonding agent and filled with SikaRepair 223 cementitious patching material (or equal). The concrete top surface should be coated with a waterproofing such as Sikalastic 22 Lo-Mod Hybrid (or equal)

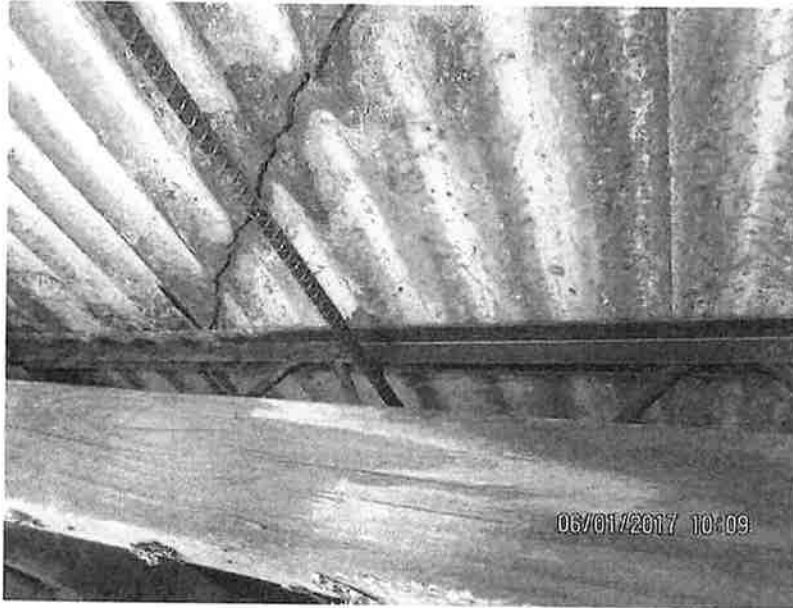
Building B – Metal deck missing

4. All open joints in the masonry wall at the balcony interface needs to be raked out and repointed to make for a weathertight joint.
5. Building B will require replacement of the existing concrete slab with new 9/16" corrugated galvanized metal deck and 4" of air entrained concrete with 6x6 W1.4xW1.4 WWF at all levels. See sketch SKS-1.

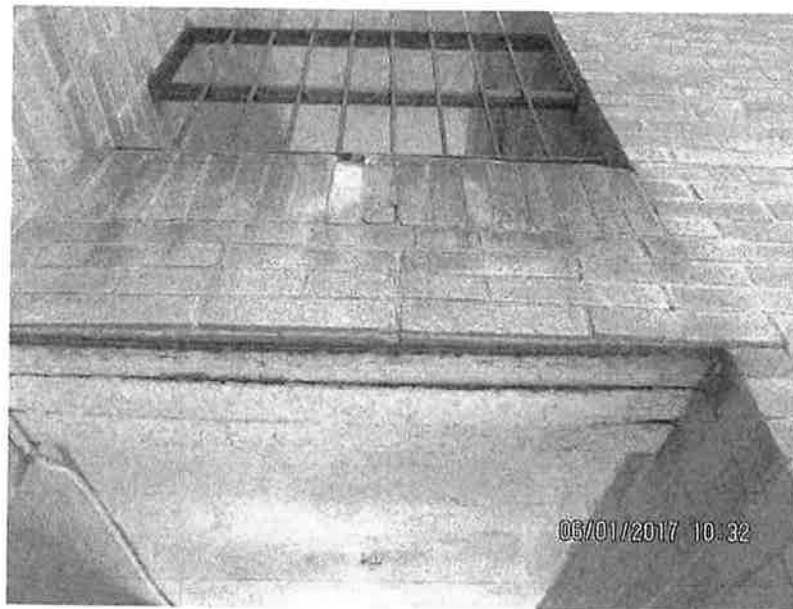
Building C – Inaccessible due to hard soffits

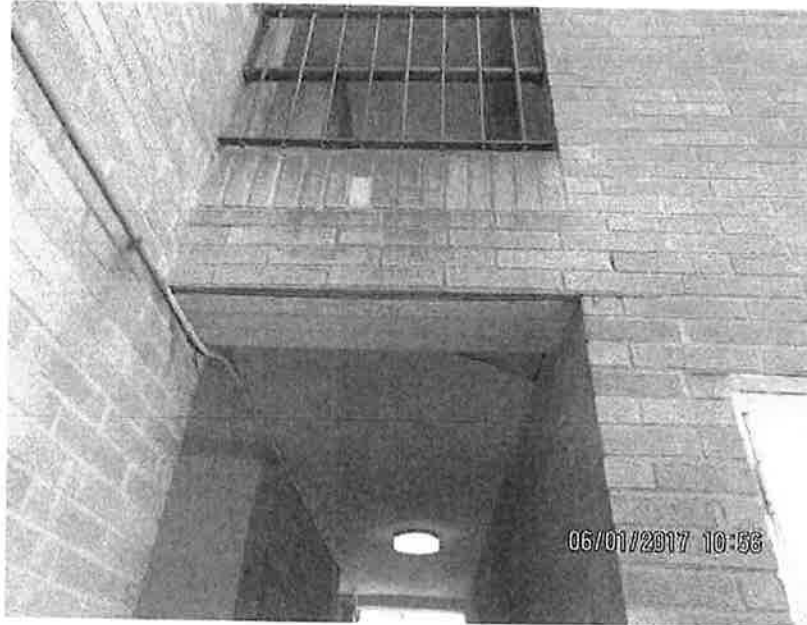
Building D – Inaccessible due to hard soffits

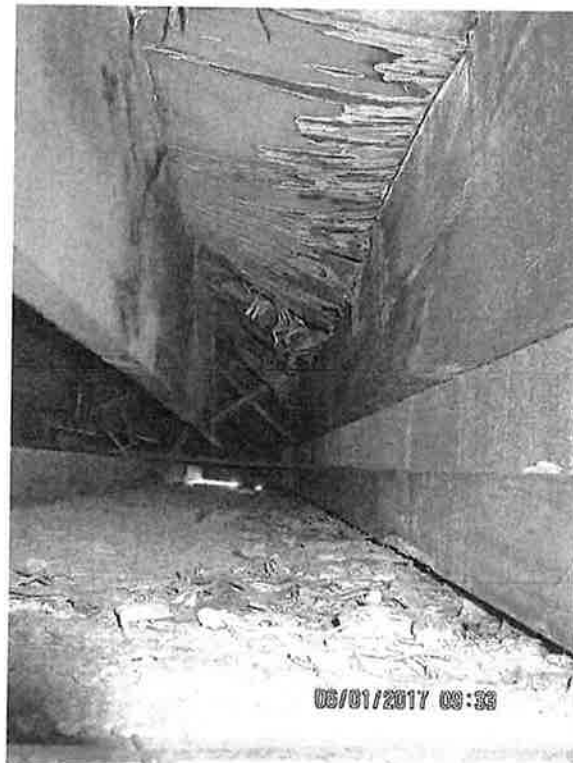
Typical roof level water damage

6. At the roof level of each stair tower the existing wood framing and existing plywood needs to be replaced. The existing wood framing and plywood appears to be non-pressure treated and is deteriorating due to moisture infiltration. We recommend that the roof levels can be rebuilt in kind but with pressure treated wood framing, water resistant plywood and a waterproof membrane at the walking surface. Keeping the water from penetrating the surface will provide longevity in the life cycle of the wood framing. This will need to be addressed at all four buildings (A, B, C & D).

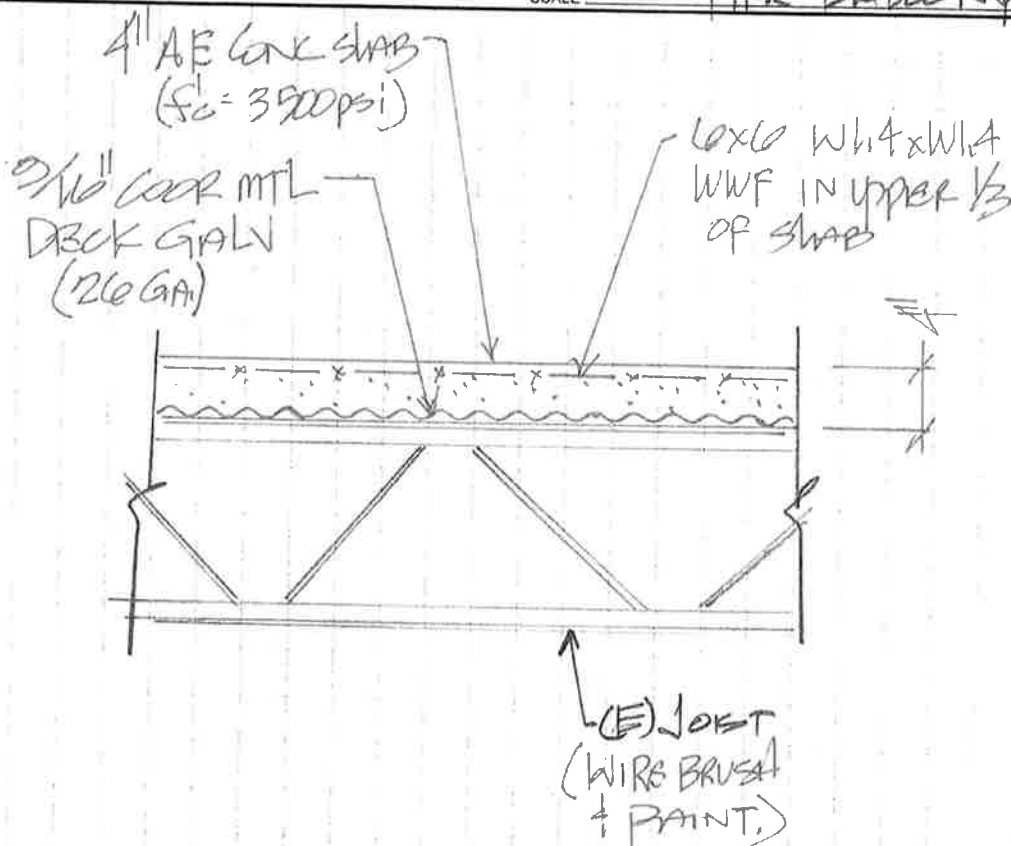
SKS-1

SLAB REPLACEMENT DETAIL
(BLDG B)
