Summary Inspection Report of FIRE ESCAPES AND FIRE ESCAPE BALCONIES

Re: Regency House
6301 N. 10th Street, Philadelphia, PA 19141
Structural Engineering Services - Fire escape inspection

The inspection status of the fire escape balconies is "SAFE WITH REPAIRS & MAINTENANCE".

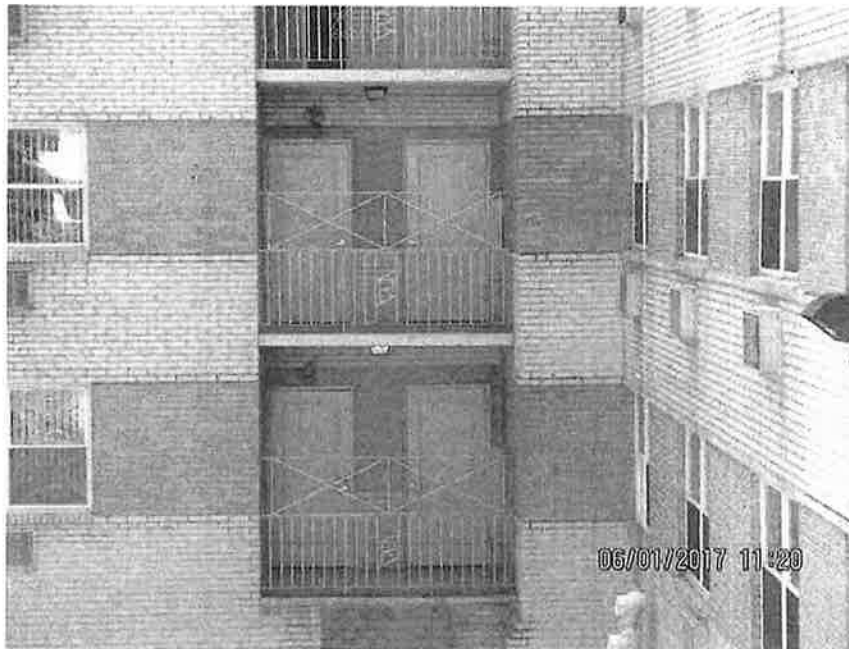
The 5 1/2" cast in place concrete slab at the fire escape balconies is in fair condition with minor top surface wear and minor spalling at the edges and the underside. The steel spandrel channel on each side shows signs of rust and minor delamination that will need to be addressed to prevent further damage. Our analysis of the fire escape balcony verifies that the existing in place framing can support the code applied loads and no structural modifications to the fire balconies are required.

Typical Balcony

2. Continue the general maintenance program of cleaning and sealing the fire balconies to prevent any deterioration. All minor surface spalls located on top of the concrete must be addressed. We recommend the spalls in the existing concrete slabs are to be repaired using Sika Armatex 110 EpoCem bonding agent and filled with SikaRepair 223 cementitious patching material (or equal). The concrete top surface should be coated with a waterproofing such as Sikalastic 22 Lo-Mod Hybrid (or equal)

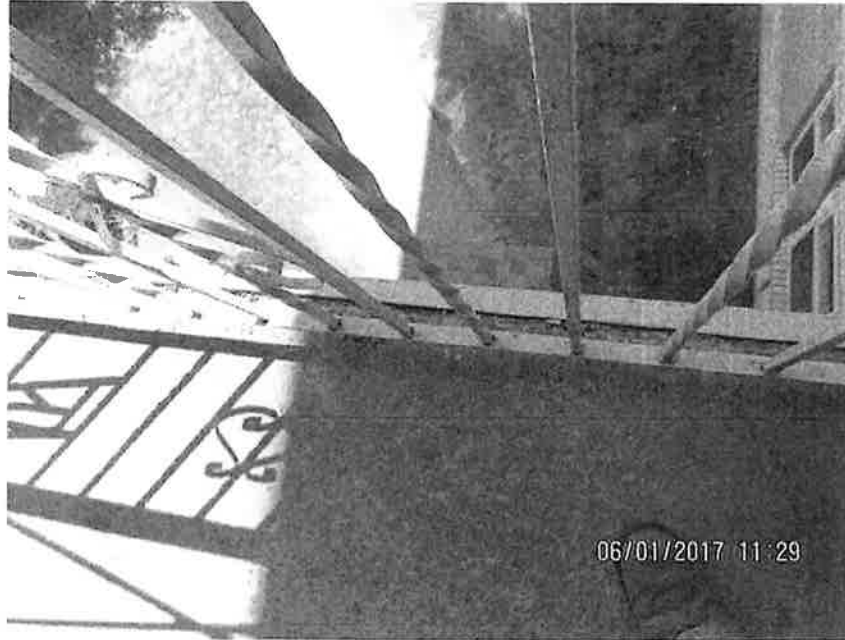
Open Joint @ Steel Channel

3. Rake out, remove all organic material and caulk/seal the top joint between the concrete slab and the steel channel to prevent water front entering the open joint, perform this task before waterproofing the balcony.

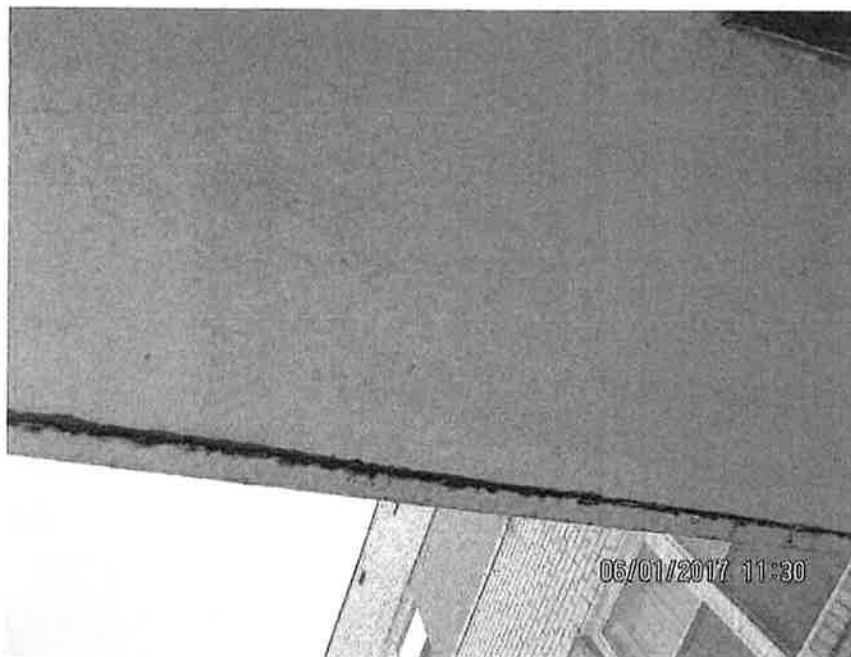
Rusted Spandrel Channel

1. Continue the general maintenance program of cleaning, wire brushing and painting of the exposed steel framing on the edges of the fire balconies to prevent any further deterioration. Notify engineer of any members that have excessive rusting or delamination for further review or replacement.

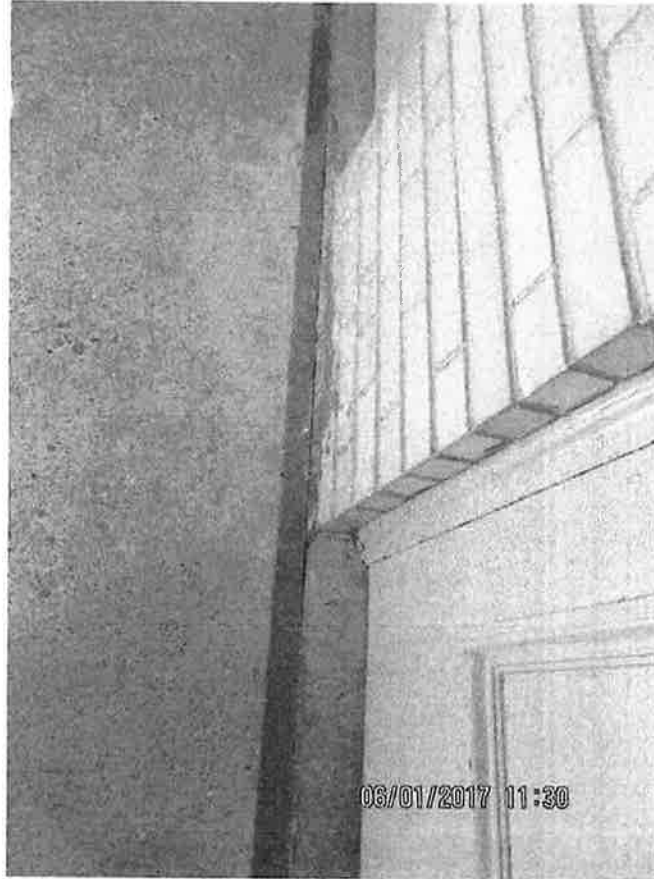
Open Joints @ Steel Channel
