## The York House Apartments 2021 Facade Inspection

Periodic Inspection of Exterior Walls and Appurtenances  
of Buildings per Philadelphia Code Section PM-315

5325 Old York Road, Philadelphia, Pennsylvania 19141

November 1, 2021  
WJE No. 2021.5484.0

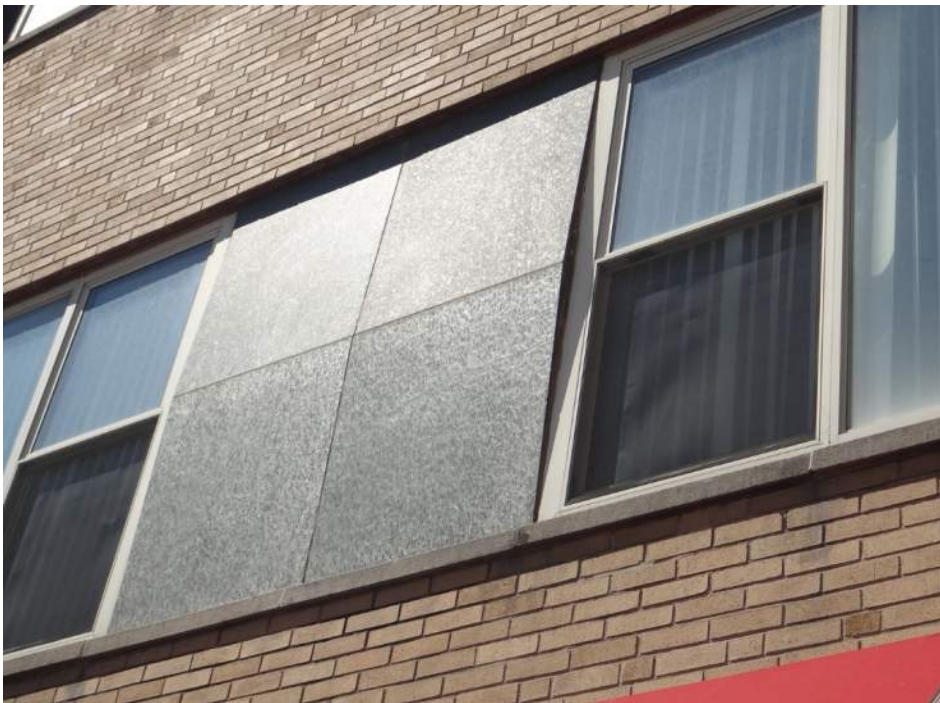
- **Bulging greenstone panels** at the east facade, ground floor level, between the first and second windows just north of the south stair tower (see Photograph 6). We immediately notified you of this condition and a follow-up inspection was performed on September 30, 2021 after temporary bracing was installed by others. The follow-up inspection included removal of the two upper greenstone panels, and it was evident that the backup CMU wall was bulging approximately one-inch outwards between floor slabs (see Photograph 7). The wall and panels have been temporarily braced until a repair is implemented.

- The greenstone panels are bulging outward due to the CMU back-up wall also bulging. Observations of the wall from the interior revealed that the metal stud and plaster wall is not moving consistently with the masonry wall. Our limited investigation did not identify a single source for the bulging, but we did notice the CMU back-up wall was originally constructed with poor craftsmanship where the CMU wall had multiple voids (see Photograph 30). It is our opinion that the wall recently experienced a localized high wind event where the poorly constructed wall had inadequate strength and started to buckle and permanently deformed outward. This location was originally identified as an UNSAFE condition that was immediately addressed with bracing. The portion of wall that is bulging requires replacement per the building code. We do not believe a repair is feasible.

Photograph 6. Greenstone panels bulging along the horizontal joint

- Displaced greenstone panels at the east facade, ground floor level, between the first and second windows. The repair is anticipated to include removing and salvaging the existing greenstone panels, demolishing the building CMU wall for the full height between the ground and first floors, and rebuilding the CMU wall, the brick veneer, and reinstalling the greenstone panels.

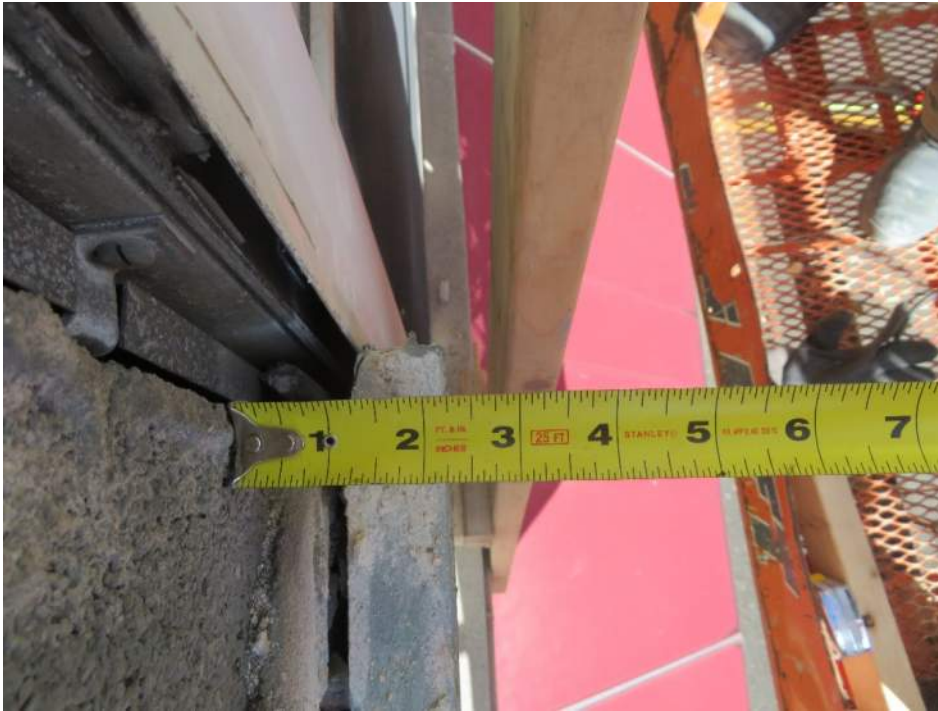
Photograph 7. Photograph of the CMU backup wall measurement where it was bowed at the center of its height

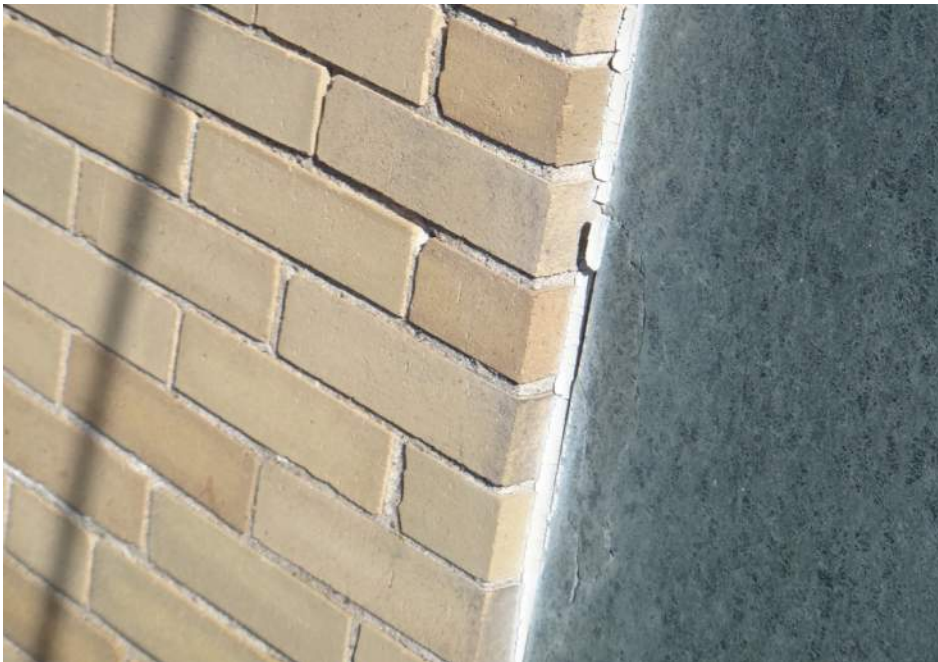
- **Incipient spall of greenstone panel** that was approximately one square foot in size located at the lower left-hand corner of the panel at the ninth story on the south facade (see Photograph 8). WJE removed the spalled material during the inspection.

- Spalling of the greenstone panel is believed to be the result of water infiltrating the stone panel likely through open joints along the perimeter, trapping moisture as a result. As the stone absorbs the trapped moisture, the moisture freezes and expands resulting in the face of the panel to spall off.

Photograph 8. Incipient spall at lower corner of greenstone spandrel panel

- The removed spall at the greenstone panel should be repaired with a compatible repair material, a dutchman repair installed, or the panel replaced.
- Above all the windows on all the elevations, the relief angles should be exposed so they can be cleaned and painted with a corrosion-inhibiting coating. This will require removal of a few rows of brick above the lintels (approximately three courses high). This will be costly, and as such can be spread out over multiple years. If the cost of removing brick, painting existing angles, and installing flashing improvements is unfeasible, the repairs can be spread out over a longer period where only the most severely corroded angles are repaired. Should the steel corrosion be severe where section loss of the steel angle exceeds 10 percent, the angle should be replaced with a hot dipped galvanized member of equivalent size and shape. New through-wall flashing should be installed, and the bricks replaced.

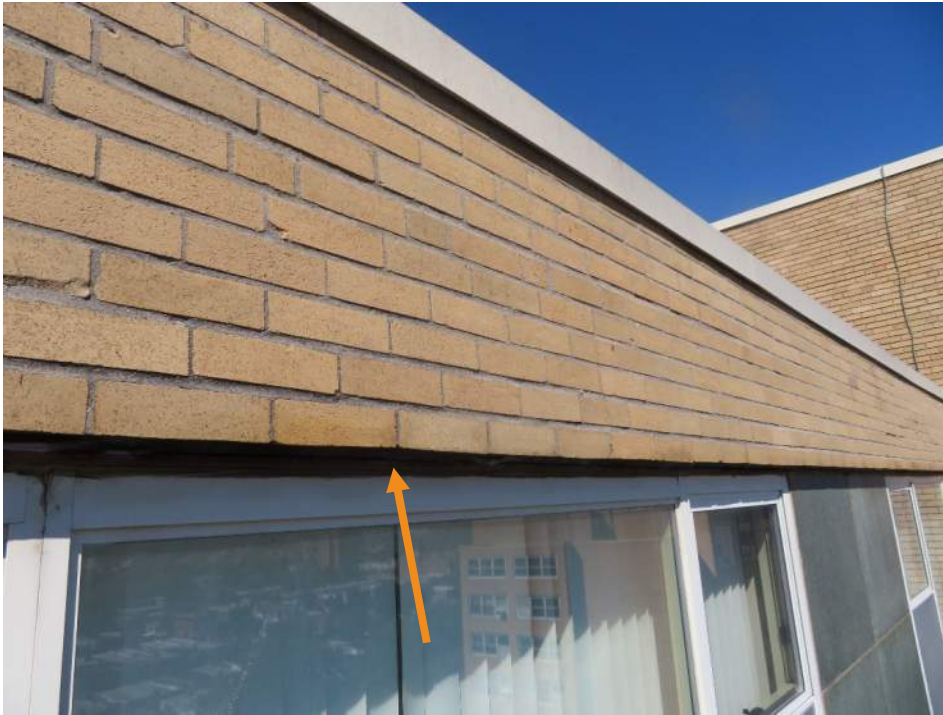
- **Corroded steel relief angles** at all the visible locations on the facade. The severity of the corrosion varied from severe to mild. We observed lintels with a mild level of corrosion where pitting was present at the toe of the angle (see Photograph 9). The angles above the twelfth-story windows on all facades and isolated angles on the east facade at lower floors were severely corroded where layers of corrosion build-up were visible (see Photograph 10). We recorded approximately half an inch of corrosion build-up at the most severe locations. At the north elevation, and portions of the east elevation, the expansion of the steel angle is believed to be the source for the leaning parapet walls (see Photograph 11). At nearly all the steel angles, sealant was installed along their length at the brick bed joint above the steel angle (see Photograph 12). This practice will trap moisture and advance the rate of corrosion of the steel. The sealant was typically failing at these locations.

- Corroded steel relief angles are the result of long-term exposure to moisture as noted above. The lack of properly performing flashings, and the lack of protective coatings reduce the lintels durability. Corroded steel lintels will expand, displacing the adjacent mortar joint or brick unit(s) as noted with the leaning parapets. Sealant installed along the toe of the angle exacerbates this condition, as the sealant traps the moisture and does not permit drainage of the exterior masonry wall assembly. Mortar with sufficient weeps holes and proper flashing assembly should be installed at these locations to facilitate drainage of the exterior wall. The installation of flashing at these locations is recommended by the Brick Industry Association and is detailed for construction of similar age.

Photograph 9. Severely corroded steel relief angle

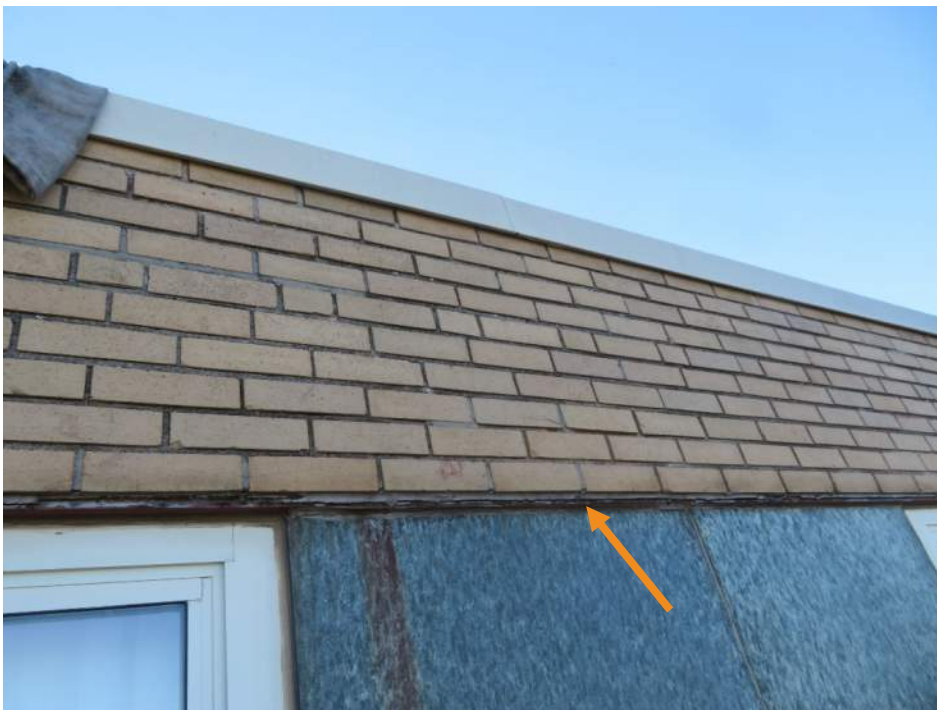
Photograph 10. Corroded steel lintel above twelfth-story windows

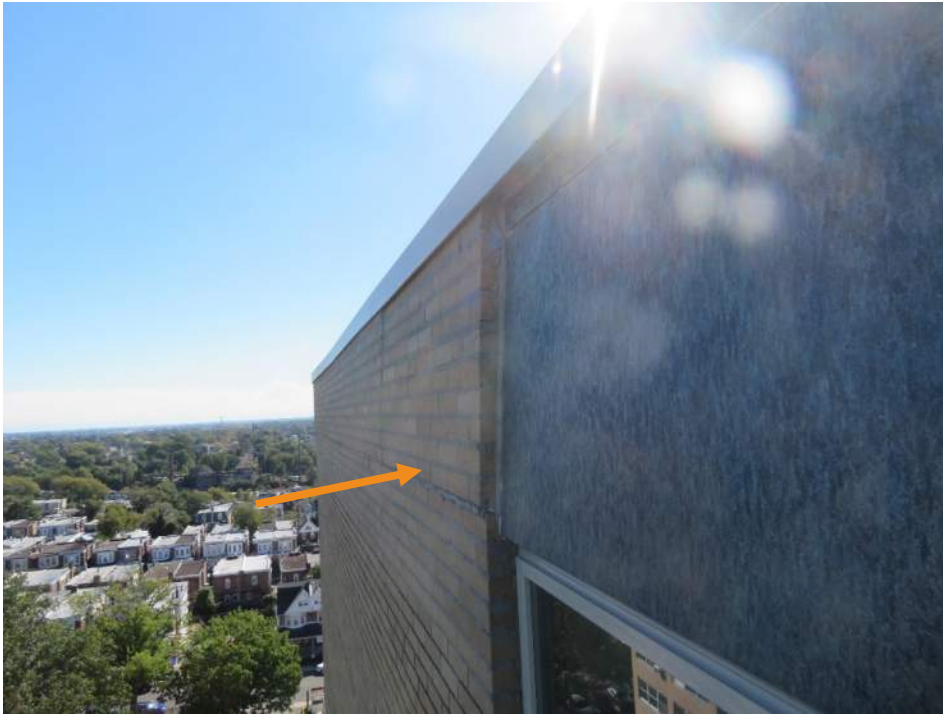
Photograph 11. Parapet wall leaning back on the north facade

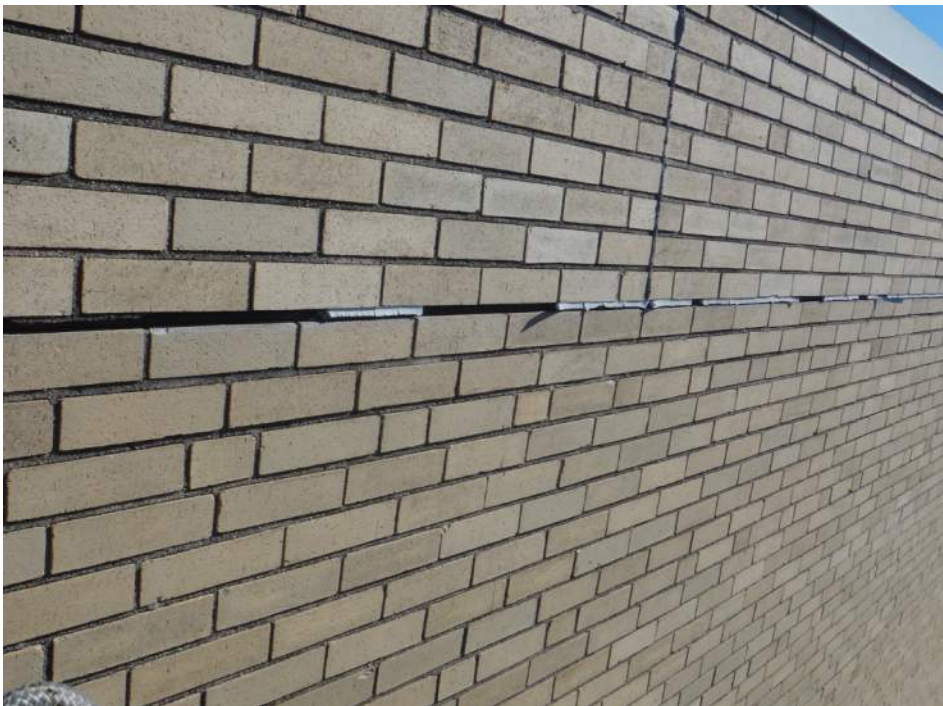
Photograph 12. Deteriorated sealant along the length of the steel relief angle

- Remove failed sealant and backer rod at all control joints and at all joints located at the perimeter of wall openings. The sealant should be replaced with new backer rod and sealant.

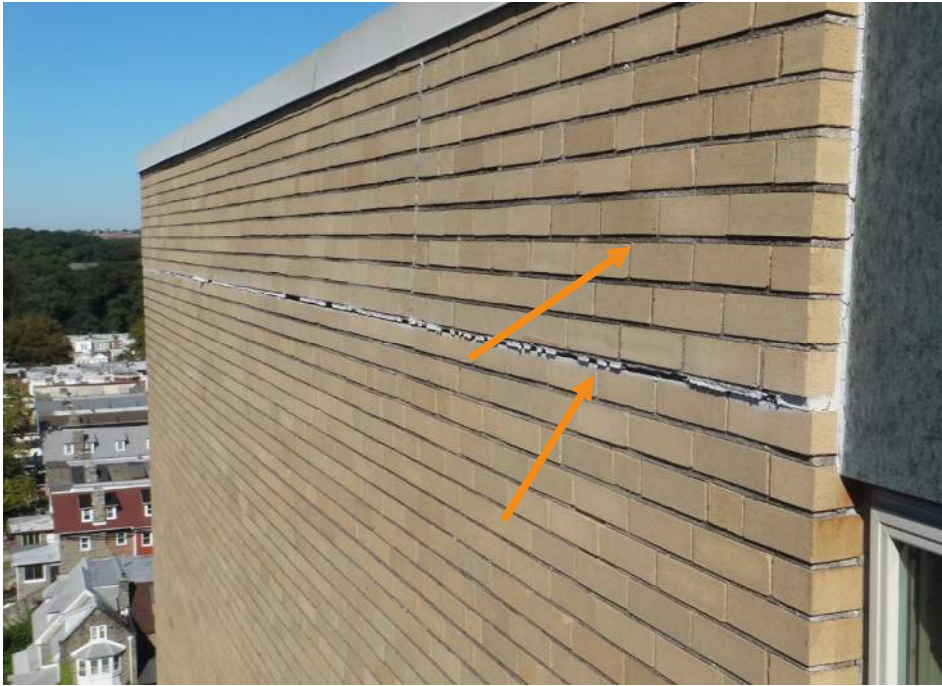
- **Displaced brick veneer** at three locations, specifically the parapet on the north facade, the parapet on the south facade, and a portion of the parapet on the east facade (see Photograph 13). The displaced brick ranged in size from approximately 30 square feet on the east facade to an excess of 50 square feet on the north facade. Additionally, bricks at the top of the chimney that extends above the roof were bulging and the coping stone was cracked and appeared displaced (see Photograph 14).

- The displaced sections of the brick veneer are caused by the expansion or rust jacking of the steel relief angle along their base. As noted, when corrosion occurs, the steel swells or expand, displacing adjacent surfaces.

Photograph 13. Displaced/bulging brick parapet wall above relief angle on the south facade and sealant installed along toe of angle

- Displaced sections of the brick veneer should be removed and reconstructed. It should be anticipated that flashing and steel lintel repairs and replacement will be required at these locations as noted above.

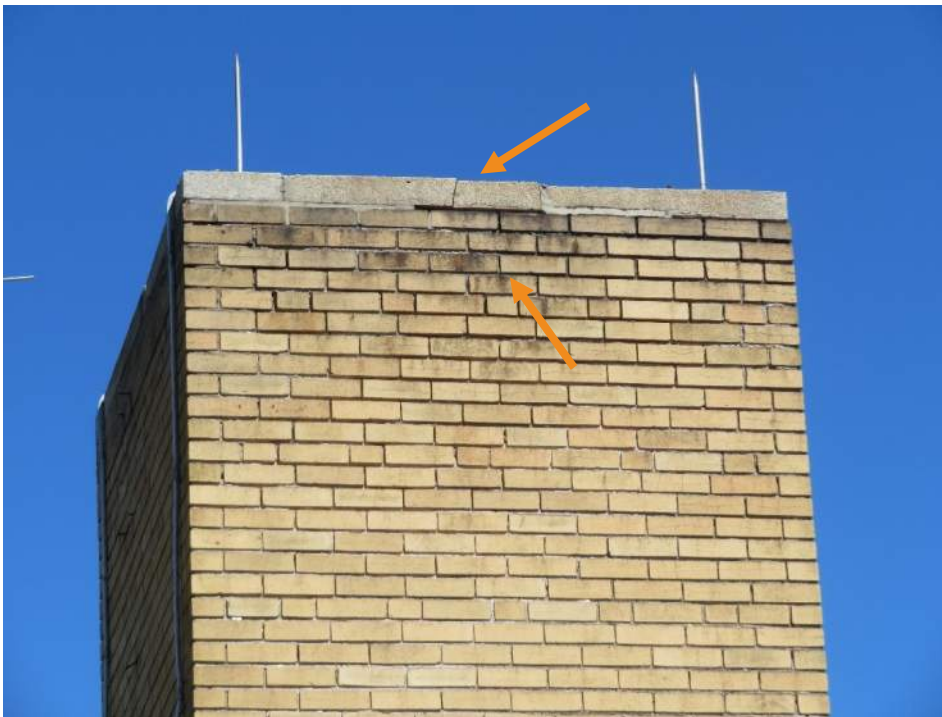
Photograph 14. Cracked coping stone units and brick bulging at the top of the chimney

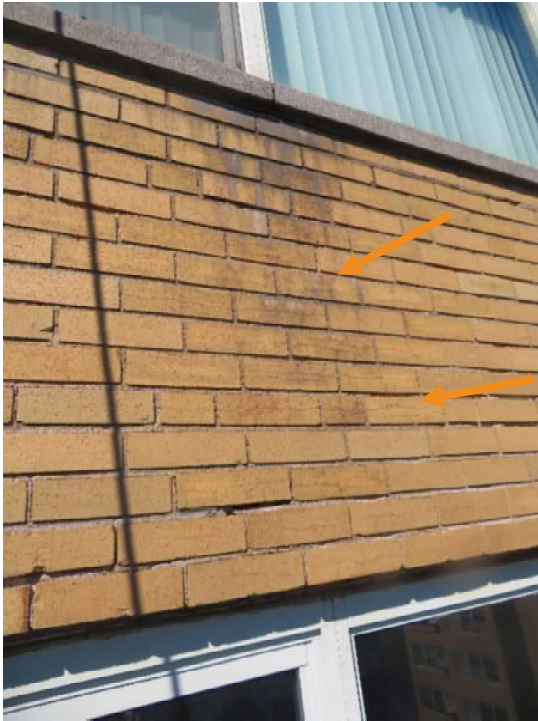
- **Cracked and scaled brick** on the east facade, north end, below open joints at windowsills (See Photograph 15). This was observed at each floor level above the eighth floor. The cracks were hairline in width and appeared to be limited to the kiln dried surface of the brick face. The bricks were sound when tapped with a hammer.

Photograph 15. Cracked and scaled brick on east facade below open windowsill joint

- The locations where brick masonry is cracked should be replaced with new. An alternative to replacing the brick is to rout and seal the cracks and fill them with sealant. The sealant will be a maintenance item and will require routine replacement every five-to-seven years.

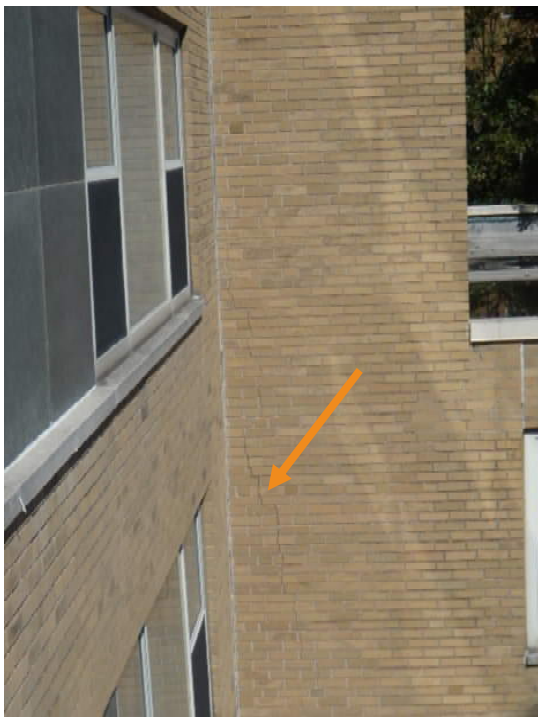
- **Vertical cracks in the brick** at isolated locations on the south and east facades (see Photograph 16 and Photograph 17). The cracks were typically a hairline to 1/4 inch in width and ranged in length from approximately two feet to over 20 feet in length.

- The observed cracks within the brick veneer were recorded at building corners or originating from the corners of wall openings and extending outward. These patterns can be from restrained movement (inadequate spacing or location of control joints), the expansion of steel lintels, or from accumulations of moisture in the wall assembly at the corners of the opening.

Photograph 16. Crack in brick veneer on the south facing side of the center stair tower on the east facade

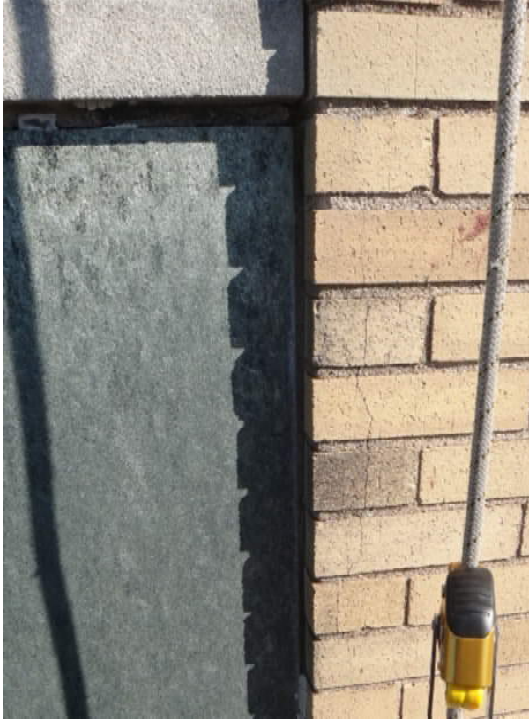
Photograph 17. Hairline brick crack on south facade

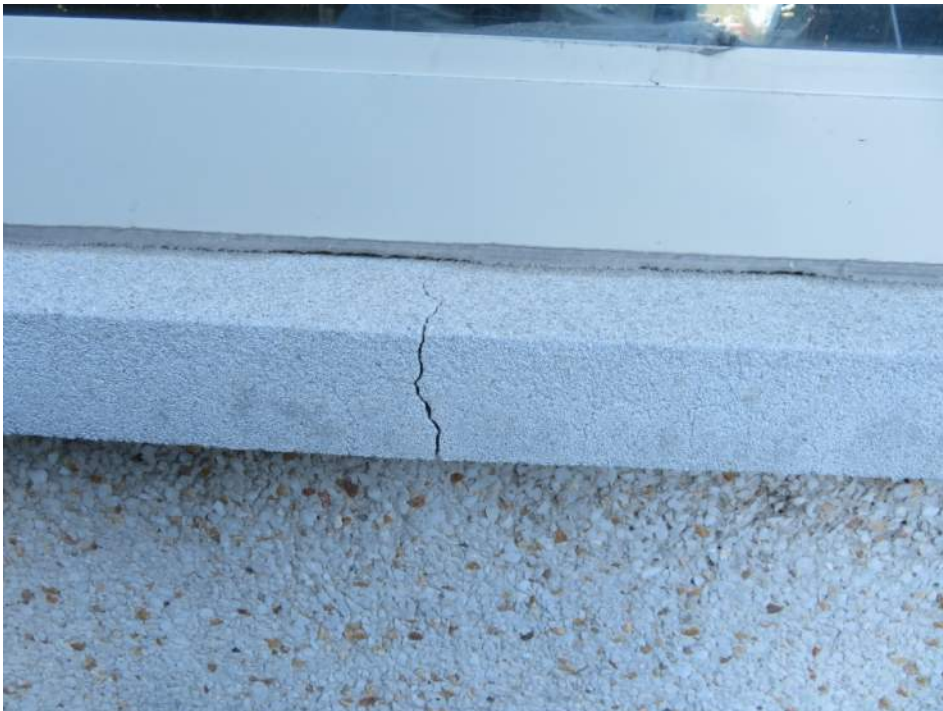
- **Cracks in the cast stone sills** at isolated locations on the west and south facades (see Photograph 18).
- **Spalled and cracked cast stone** at two locations on the west facade (See Photograph 19 and Photograph 20). They were recorded at the sixth and tenth story levels and ranged in size from one-to-three square feet.

Photograph 18. Crack in precast stone sill on the west facade

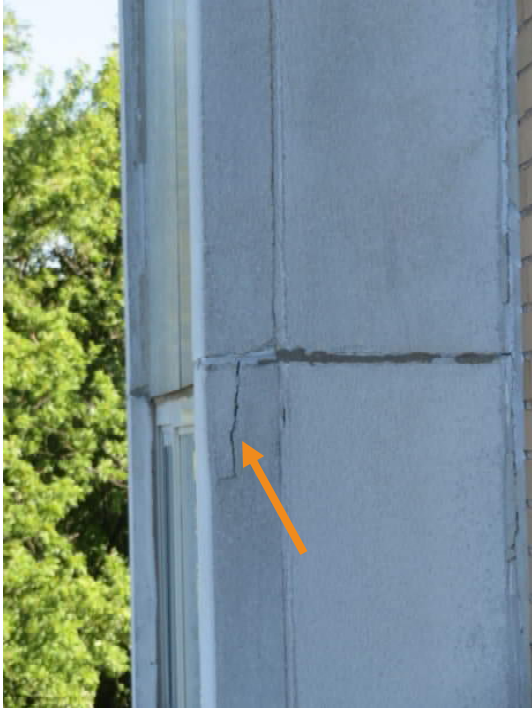
- The two cast stone spalls were noted near the base and top of the cast stone units, directly adjacent to open mortar joints. It is our opinion moisture accumulated in the joint and was absorbed into the stone that resulted in cracking during freeze/thaw cycles. The stones will continue to deteriorate until the unsound material is removed and the joint repaired.

Photograph 19. Incipient spall at cast stone at west facade

- The spalled cast stone should be cut out and repaired with a compatible repair material or a dutchman repair installed.
- Remove and replace deteriorated mortar joints between all the greenstone panels, mortar joints within 12-to-16 inches above steel lintels (only if the lintel repairs are not performed), and mortar joints at all the parapet walls. Eroded mortar joints within the field of the brick veneers should be repointed. Existing mortar should be removed to a minimum depth of 3/4 inch or twice the joint width and filled with new mortar to maintain the longevity of the masonry wall assembly.

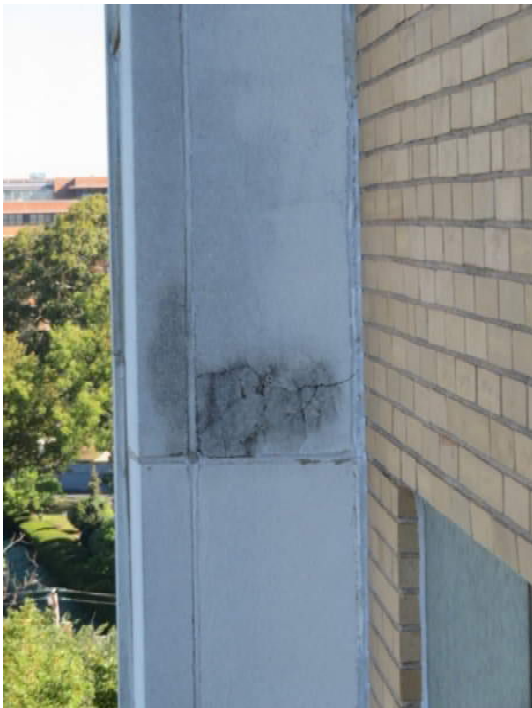
Photograph 20. Crack in cast stone on west facade

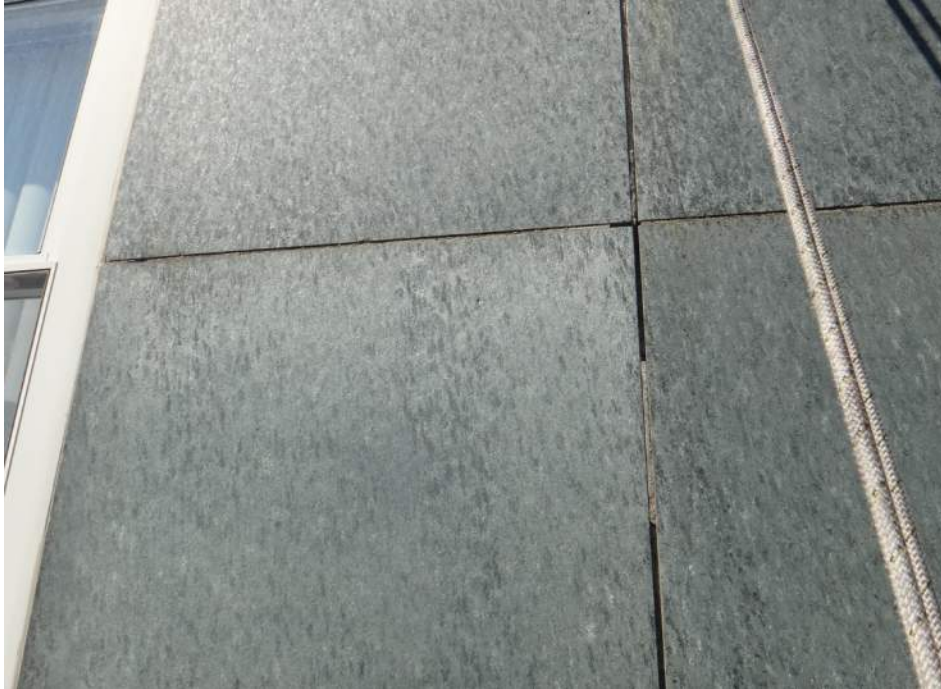
- **Deteriorated and open mortar joints** at multiple locations on all facades. Typical conditions included the vertical and horizontal joints between greenstone panels (see Photograph 21), precast stone sill units (see Photograph 22), and at multiple areas in the brick veneer on all facades (see Photograph 23). All the greenstone mortar joints appeared to be in poor condition with unbonded and partially open mortar joints. The mortar was frequently eroded and missing in the brick mortar joints directly above the steel lintels on all the facades, and more frequently near the upper floors of the building. These deficient mortar joint areas in the brick ranged in size from approximately 20 to 950 square feet.

- There was a pattern to the locations of the deteriorated mortar joints in that they were commonly located at the parapet walls, directly above steel lintel locations, and the tops of the chimney. These are locations where the moisture content is expected to be the highest and where the walls experience more severe temperatures in the winter season. The decline of the material will start at these locations due to deterioration from freeze/thaw cycles. Repointing of the mortar joints is necessary to maintain the durability and longevity of brick veneer. The Brick Industry Association guidelines for wall maintenance include repointing every 25 years. Although this is only a guide, it helps maintain the wall in great condition. The location of the mortar deterioration is consistent with a decline in mortar at the most susceptible areas.

Photograph 21. Deteriorated/open mortar joints between greenstone panels

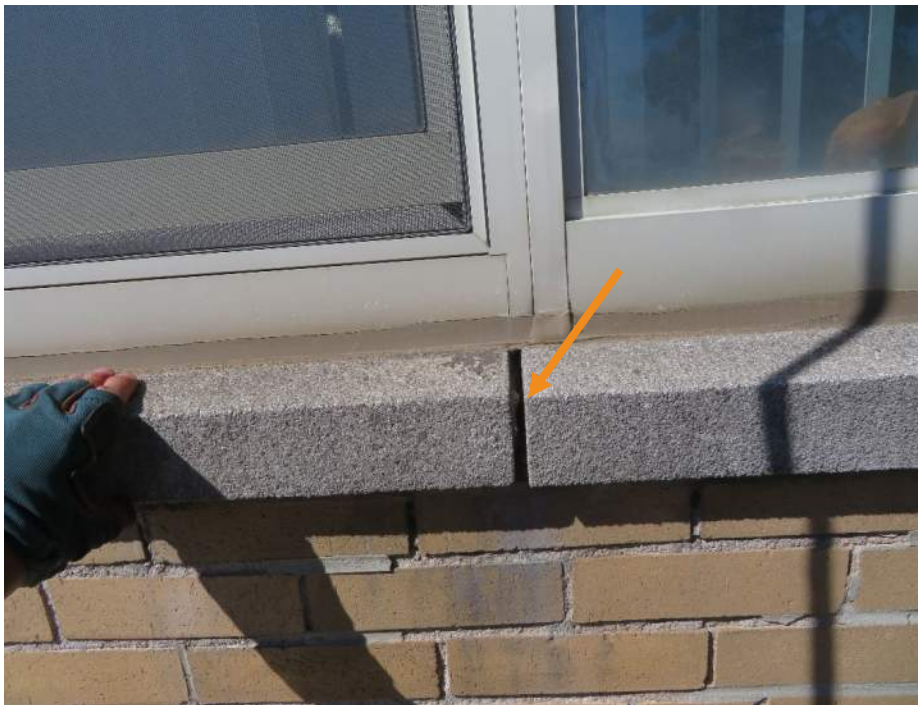
Photograph 22. Voids within joints between precast stone sill units

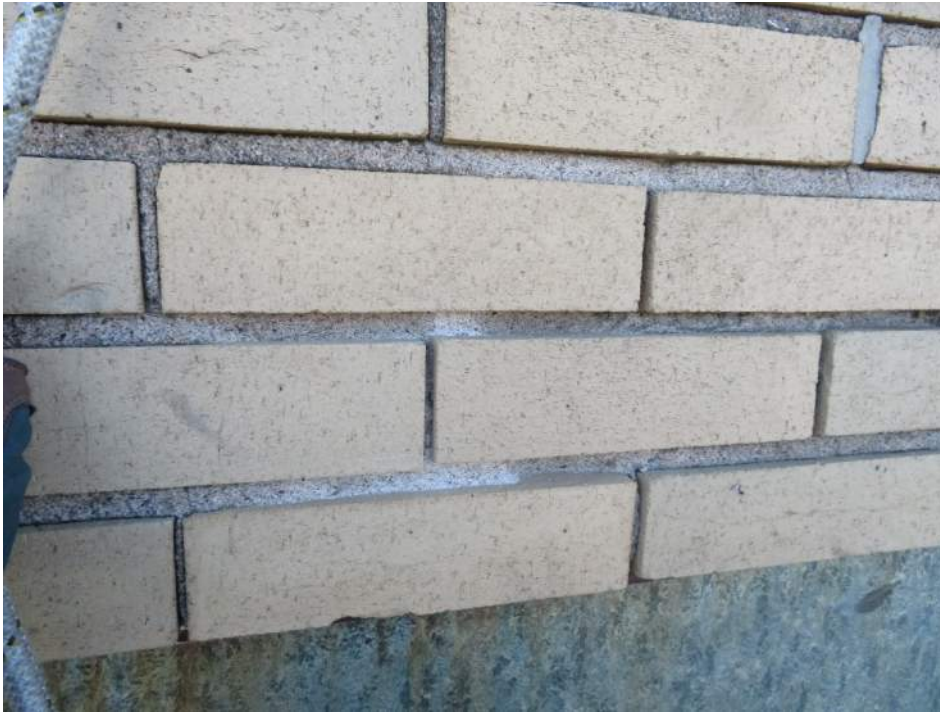
Photograph 23. Eroded mortar joint between brick units

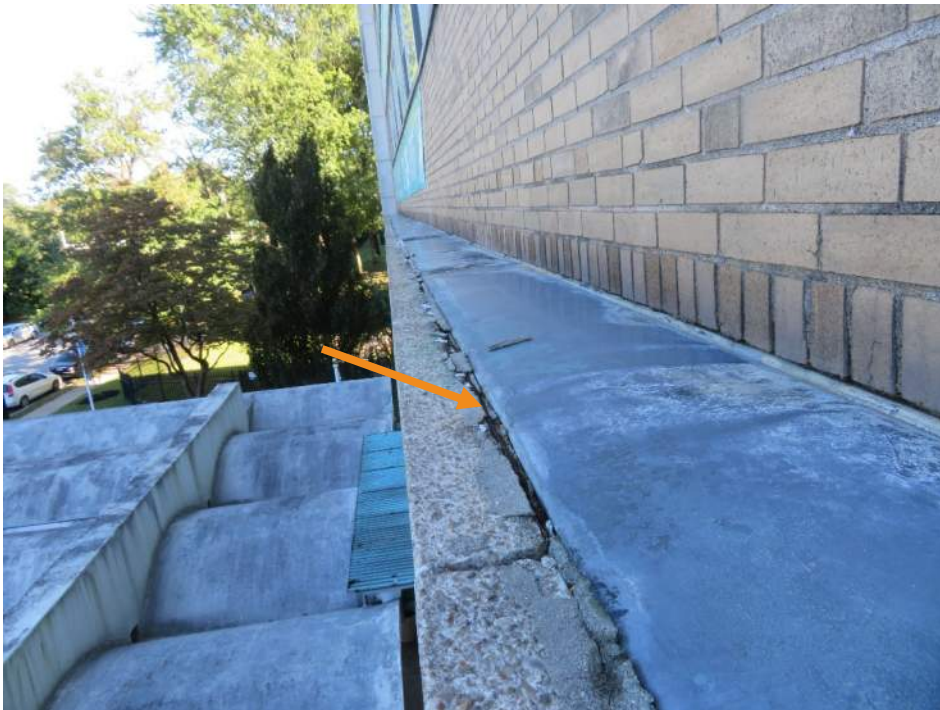
- **Open termination and failing mortar at the flashing** over the cast stone collar banding on the west facade (see Photograph 24). The mortar is failing, unbonded, and the termination of the metal flashing is loose and separating in the cast stone joint. This condition will permit water infiltration that could damage cast stone masonry units and support structure below.

- The termination and original detailing of the flashing above the precast band was likely intended to provide the benefit of flashing the horizontal ledge while hiding its appearance. However, the lack of maintenance has resulted in the joint deteriorating and a susceptible joint for water infiltration. The flashing terminates in a reglet along the top edge of the precast with mortar sealing off the joint. The mortar at this location has failed because of the skyward-facing nature of the joint and the lack of expansion capability of the mortar material. Aside from the joint being directly exposed to rain and snow, the flashing directs water underneath the mortar joint. As moisture freezes and expands, the adjacent mortar spalls off creating an open joint along the back face of the precast. The flashing should ideally extend across the full width of the precast and terminate in a drip edge to allow water to drain off the ledge.

Photograph 24. Deteriorated mortar joint along top edge of precast surround on the west facade

- Installation of new metal flashing above the cast stone collar course on the east facade. The flashing should include expansion joints due to its long length and it should extend across the full width of the projecting course with a drip edge over the top edge of the cast stone.

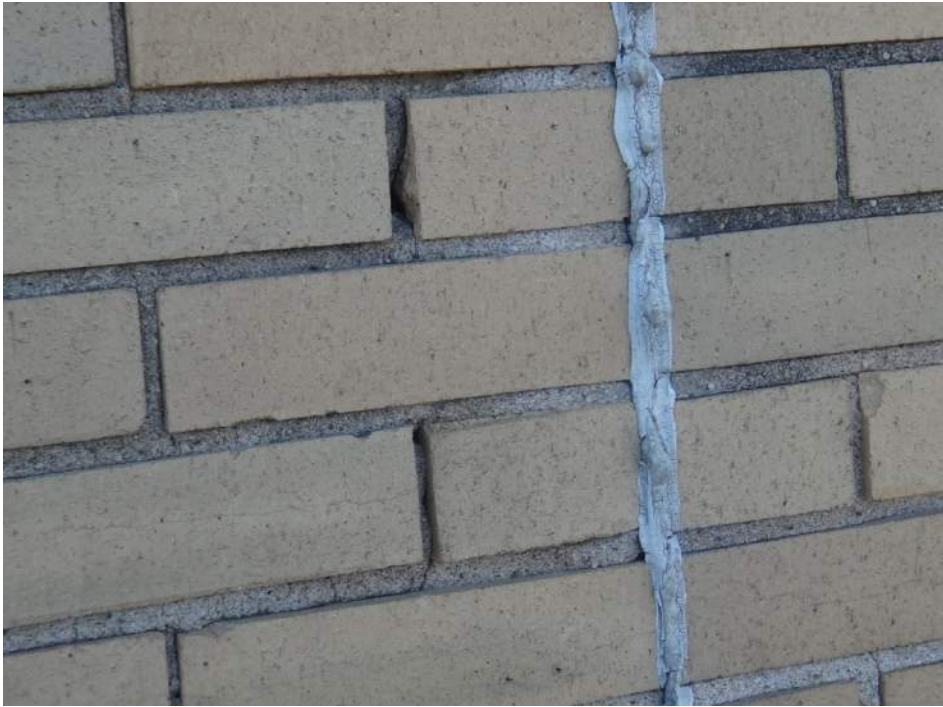
- **Adhesive and cohesive sealant failures** at control joints and at the perimeter of window and wall openings on all facades (see Photograph 25 and Photograph 26). Sealant failures were also observed at locations where sealant was installed at incorrect locations. These locations include at the toe of the relief angles (see Photograph 27), at the base of the greenstone panels (see Photograph 28), and along the bottom of sill units at the bed joints (see Photograph 29).

- The sealant failures are believed to be from age and the improper application at locations where sealant is determinantal to the facade performance. Sealant typically has a seven-to-ten-year service life before it becomes brittle and loses its elasticity due to long term UV exposure. The sealants appeared hard or stiff when probed. The application of sealant at locations where it was applied at the toe of steel lintels or where it was "buttered" over joints are not consistent with industry standards and will fail prematurely as noted. Sealant should be installed in accordance with the sealant manufacturer's requirements for proper installation, typically a 2:1 width-to-depth ratio. The sealant should also not be installed where it will trap moisture in the wall assembly.

Photograph 25. Deteriorated sealant at control joint

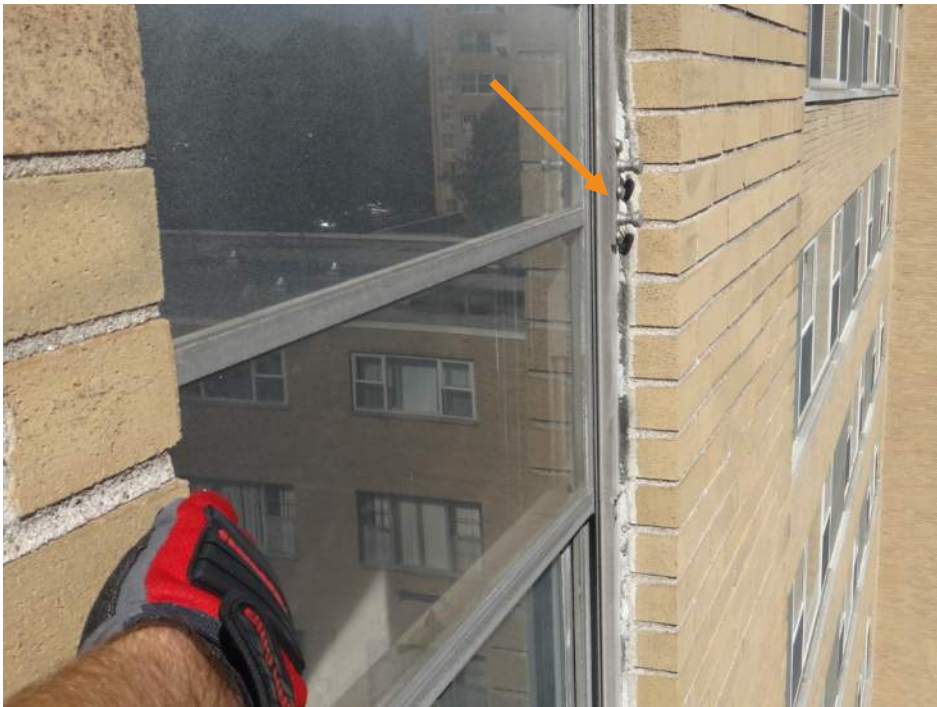
Photograph 26. Deteriorated sealant around the perimeter of the window

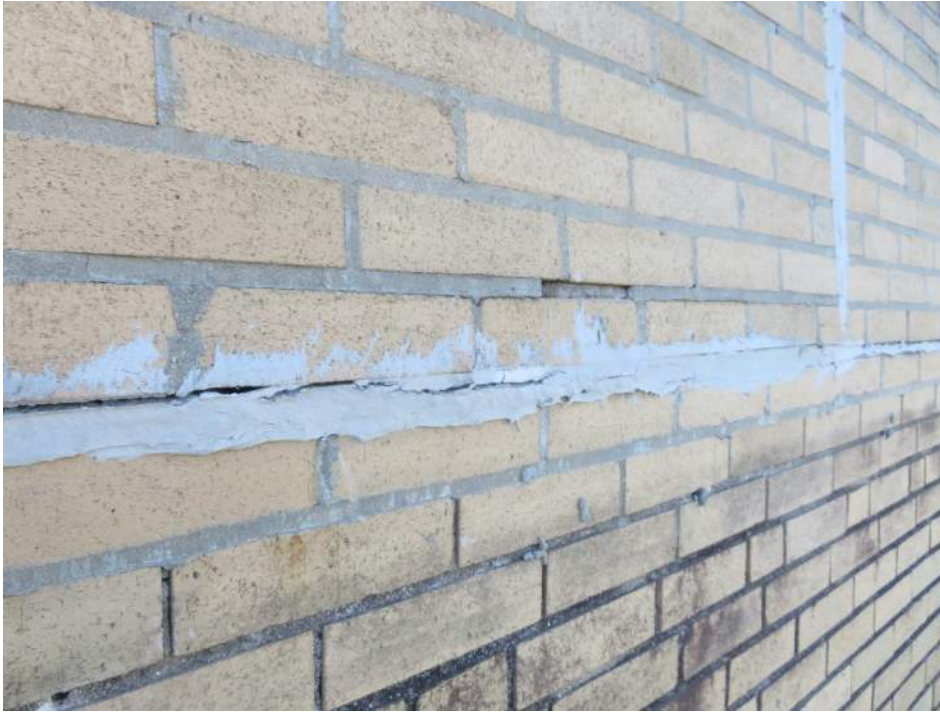
Photograph 27. Adhesive sealant failure along relief angle

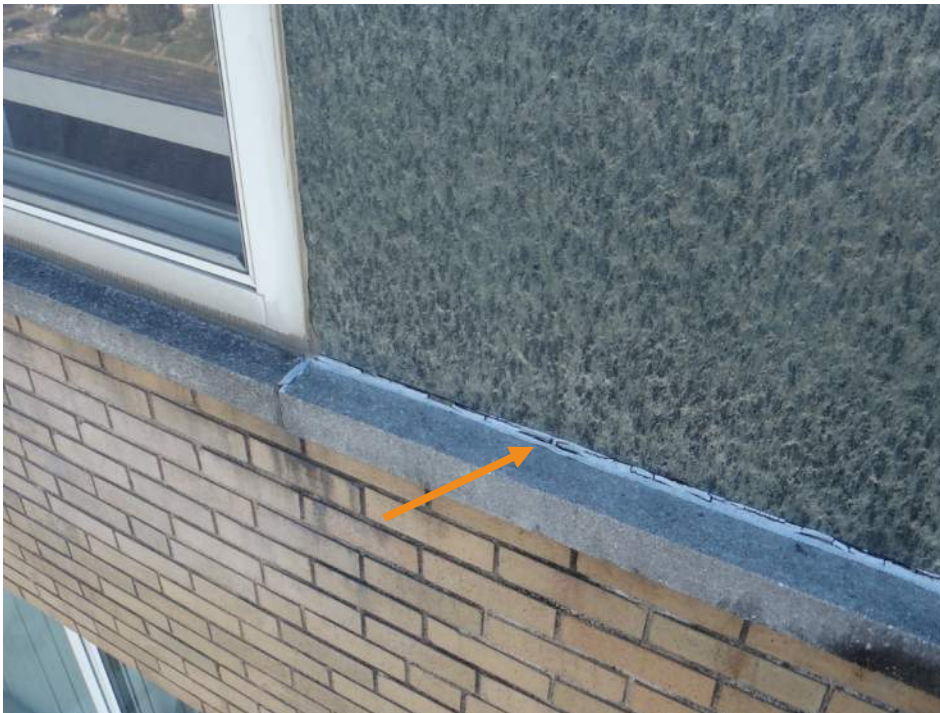
Photograph 28. Adhesive sealant failure between greenstone panel and precast stone sill

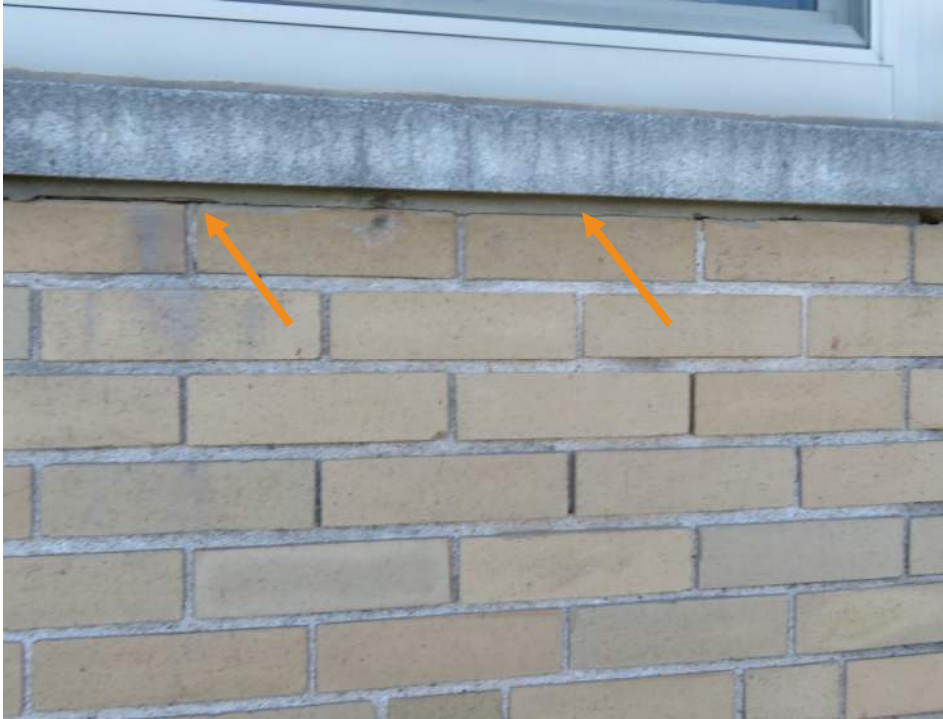
Photograph 29. Sealant present below precast stone sill

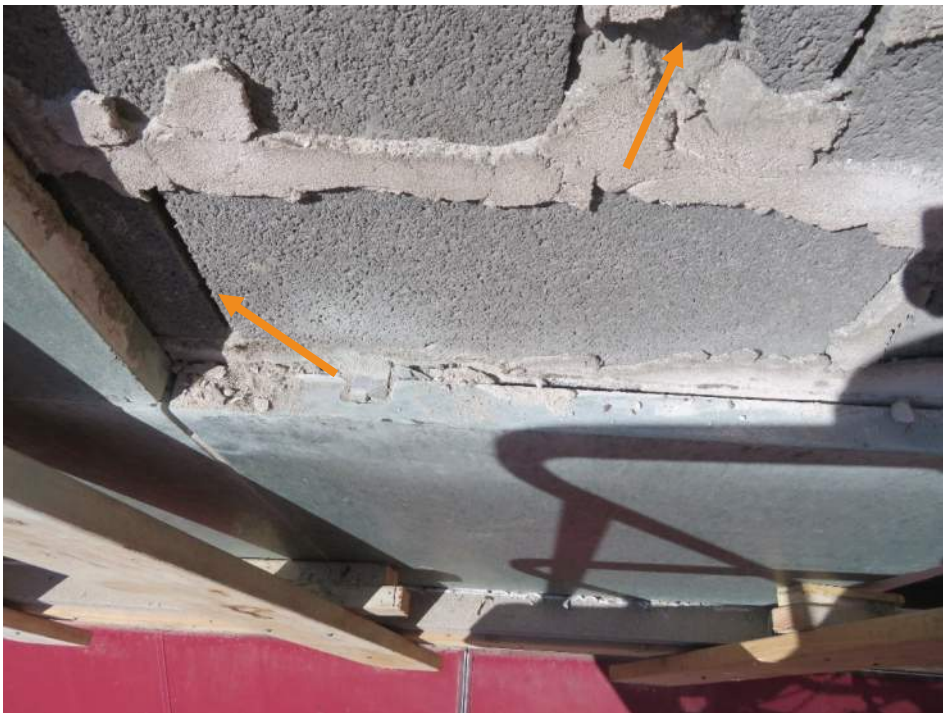
Photograph 30. Voids in CMU back-up wall
